# TOTAL PROPERTY INSPECTION

## TPI WHOLE HOME INSPECTION

1234 Main Street  
Palm Bay, FL 32905

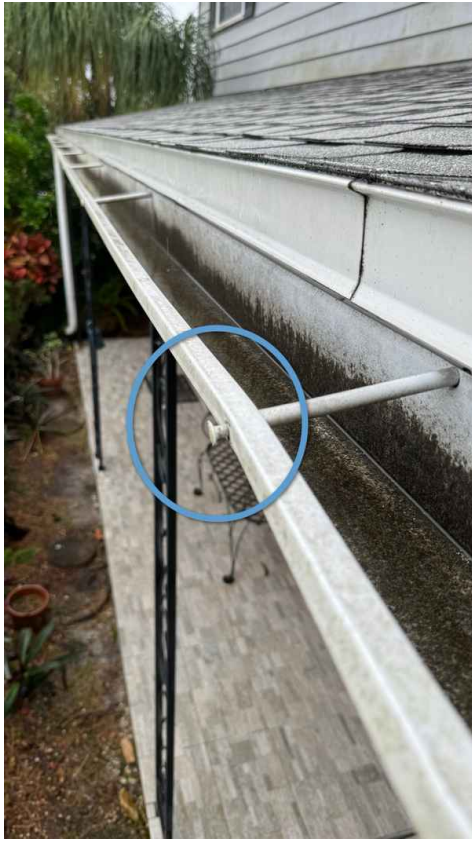
2.3.1 Gutters & Downspouts

### GUTTER LOOSE

I observed one or more gutters that were loosely attached to the house.

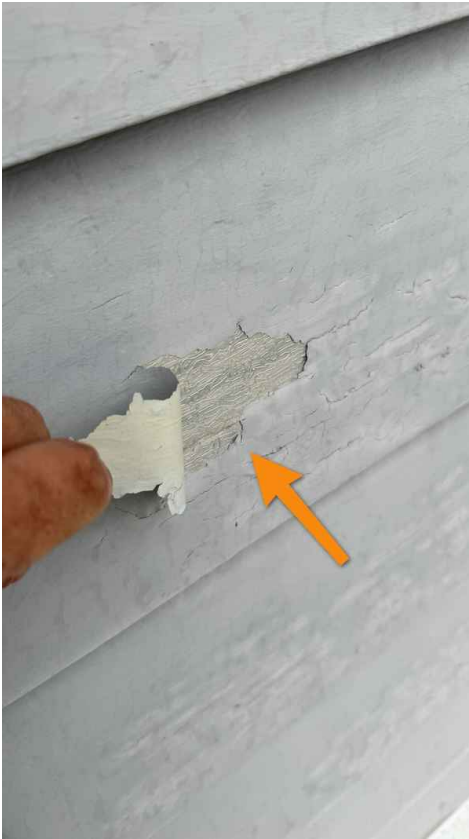
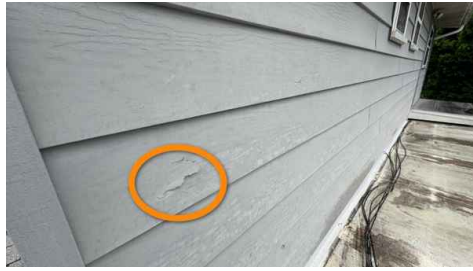
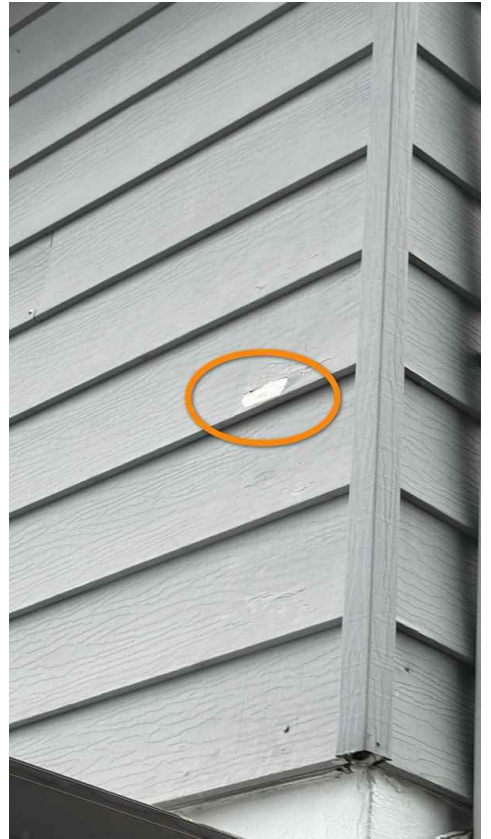
At time of inspection, one or more areas of exterior siding paint is peeling. Due to the home being manufactured pre-1970, there is a risk of lead-based paint. Recommend painting over an encasing lead-based paint to prevent any hazards.

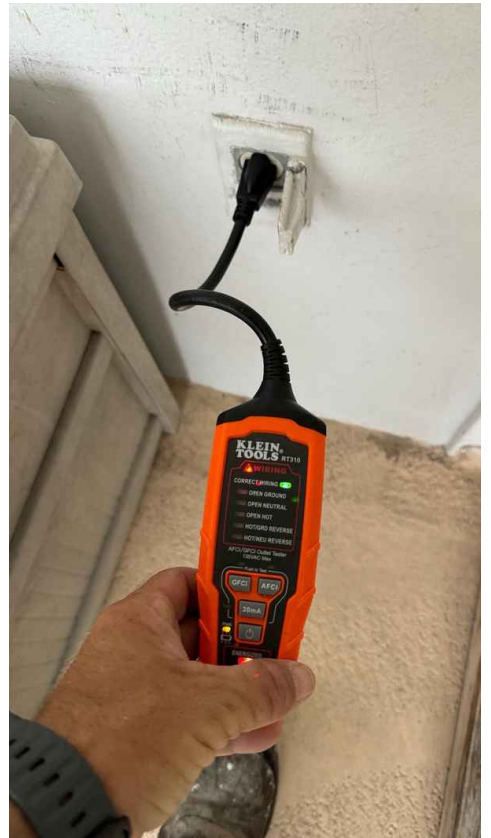
3.5.1 GFCIs & Electrical

**MISSING GFCI**

I observed indications that a GFCI is missing in an area that is required to keep people safe.

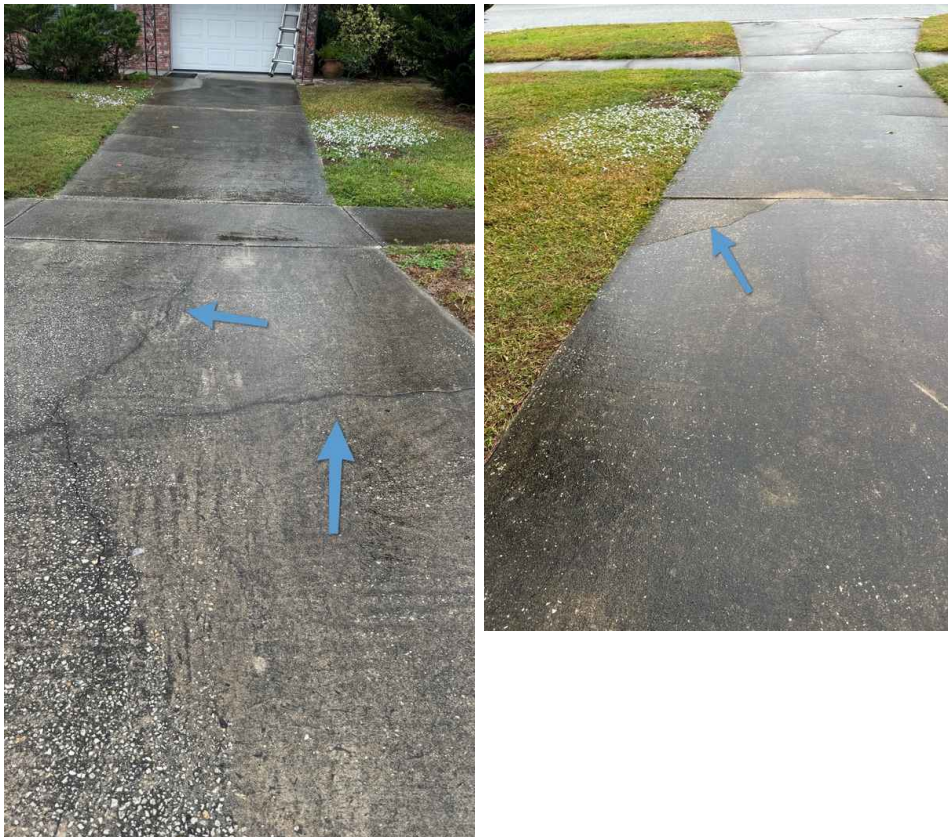
3.6.1 Walkways & Driveways

**MINOR CRACKING AT DRIVEWAY**

I observed indications of minor cracking at the driveway most likely due to settling.  
Recommend continued Watch to ensure further deterioration

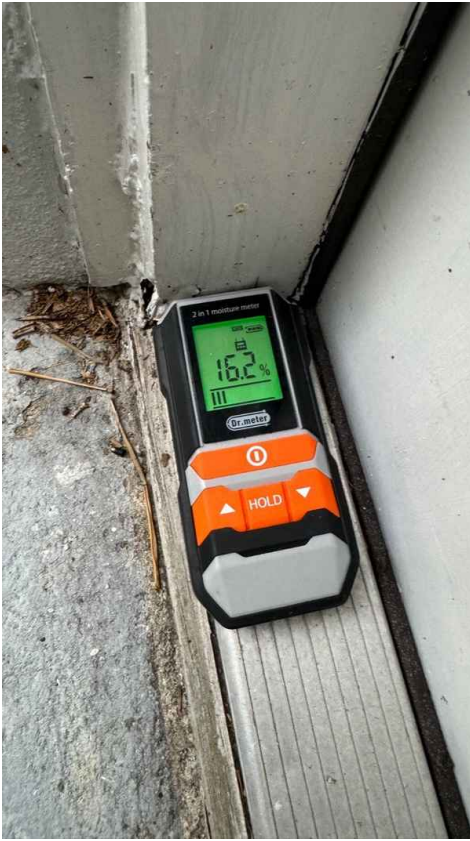
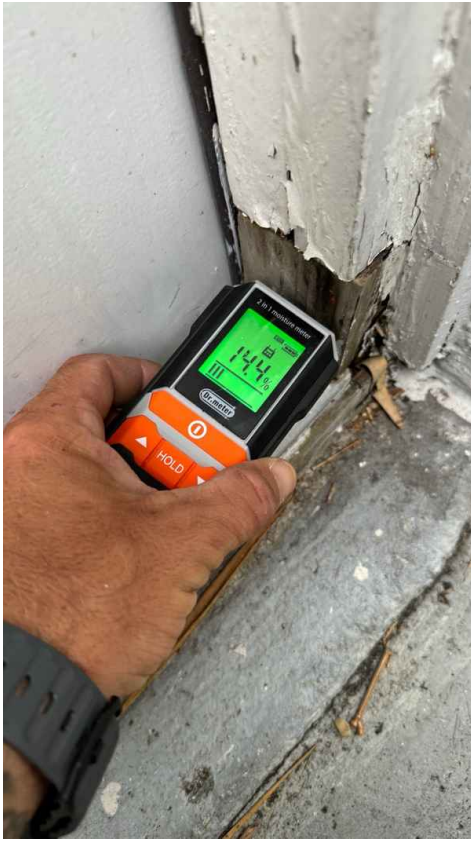
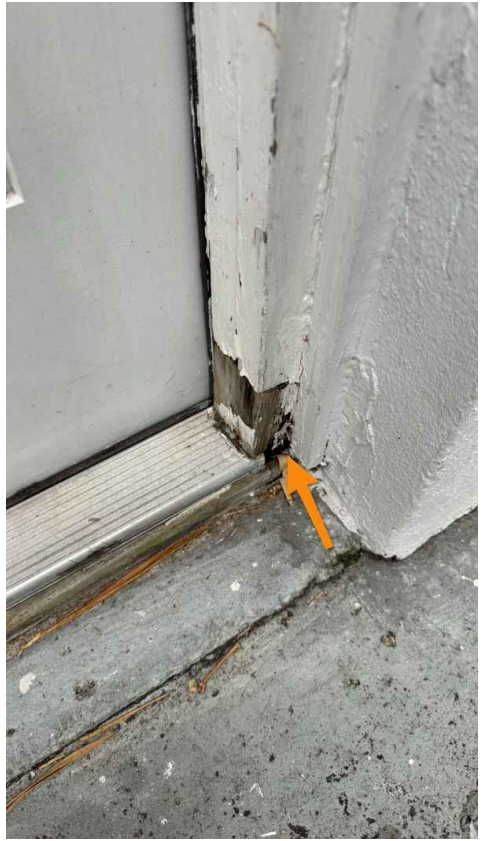
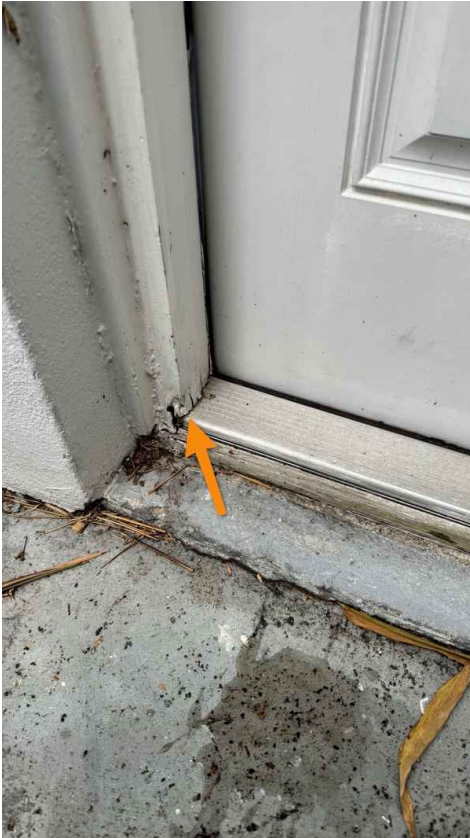
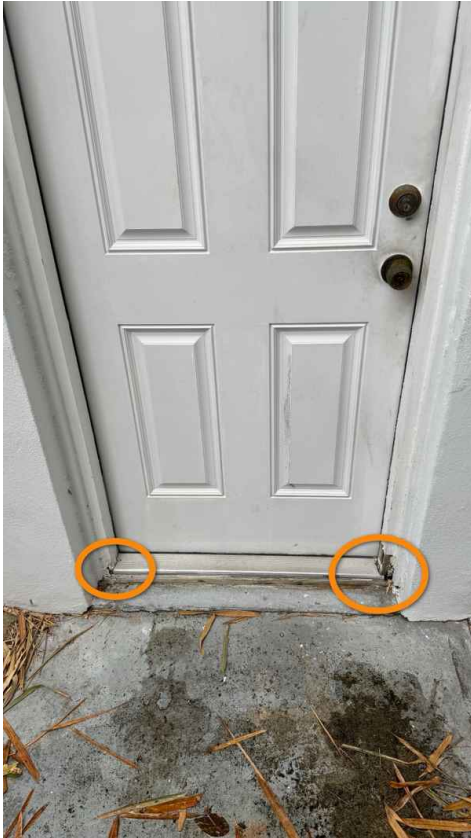
3.9.1 Exterior Doors

**WOOD ROT AT DOOR**

I observed wood rot at the exterior door.

Correction and further evaluation is recommended.

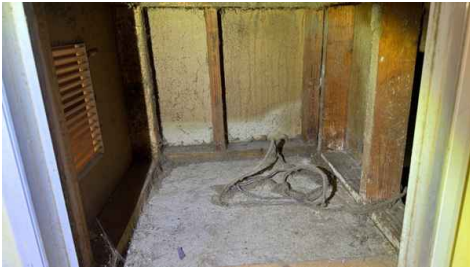
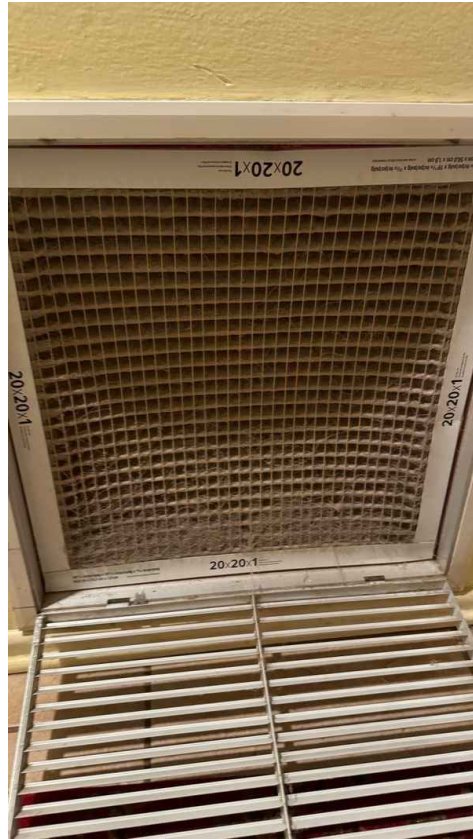
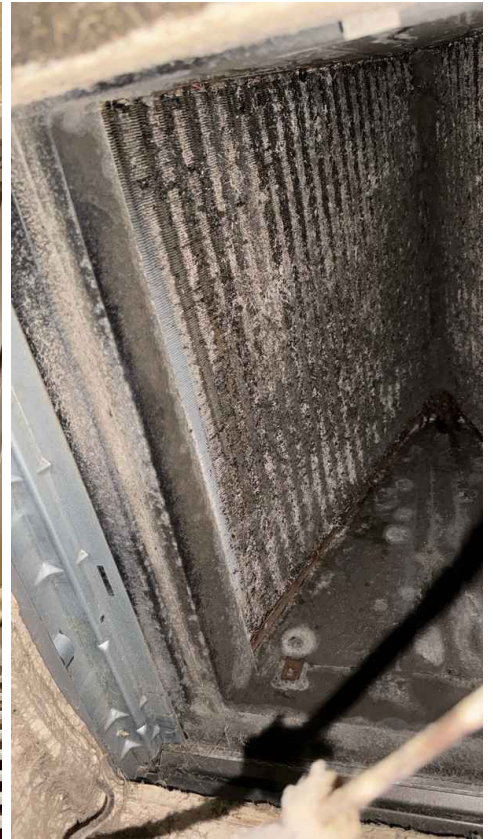
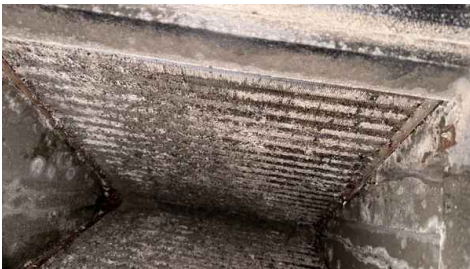
Add time of inspection, HVAC handler extremely dirty. Recommend cleaning and changing air filter.

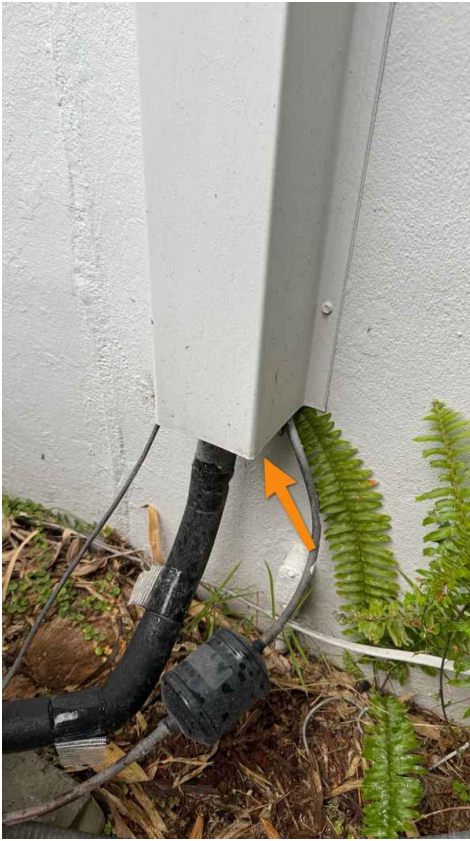
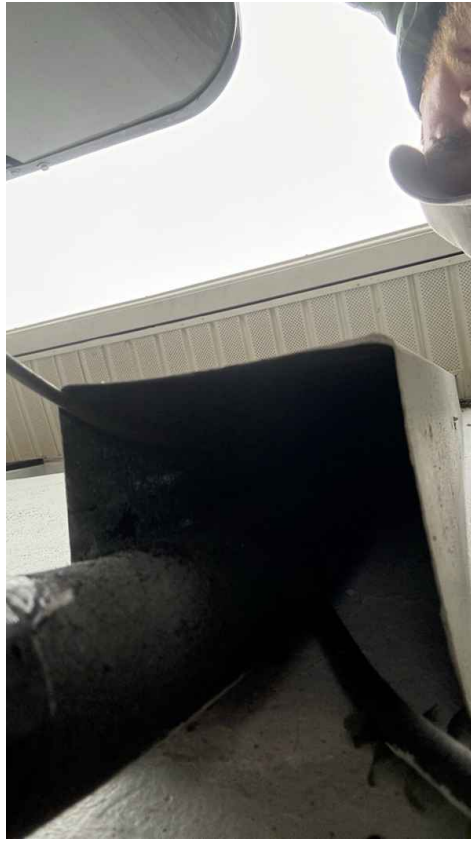
### 5.3.1 Condensate

#### **MISSING SEALANT**

At time of inspection, there appears to be missing sealant where AC lines run into soffit through attic. Recommend filling with expanding foam to prevent animals or insects from entering the attic.

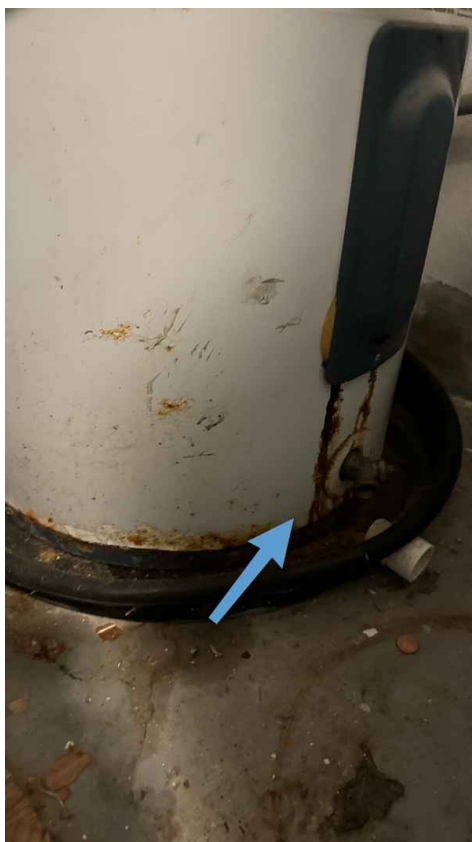
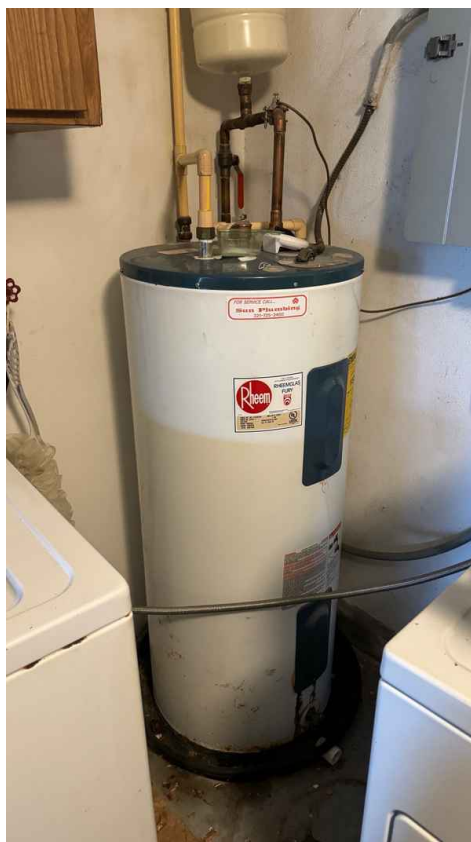
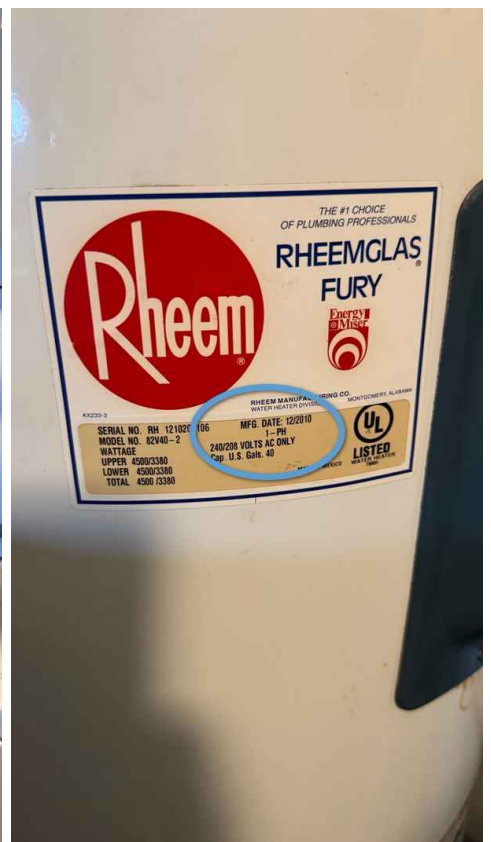
**OLD SYSTEM**

I observed during my inspection that the system appeared to be old and at the end of its service life. It may not be reliable. Ask the homeowner or occupant about its recent performance. Regular maintenance and monitoring of its condition is recommended. Budgeting for repairs and future replacement is recommended. [InterNACHI's Standard Estimate Life Expectancy Chart for Homes](#)

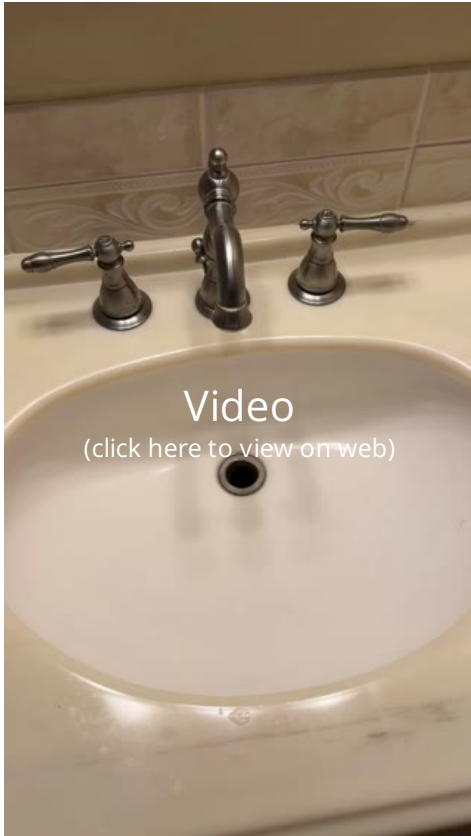
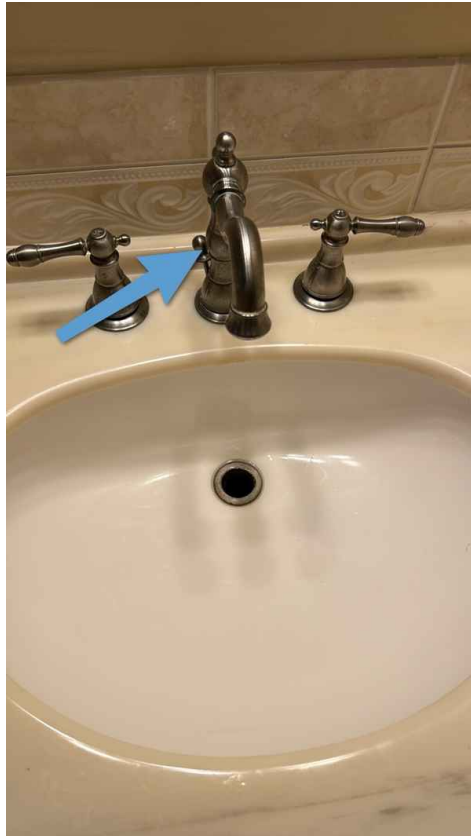
##### **HANDLE LOOSE**

I observed that the fixture handle is loose.

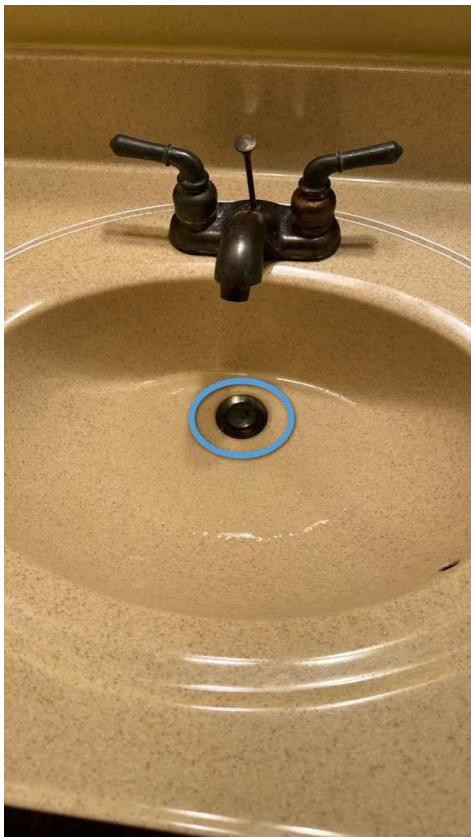
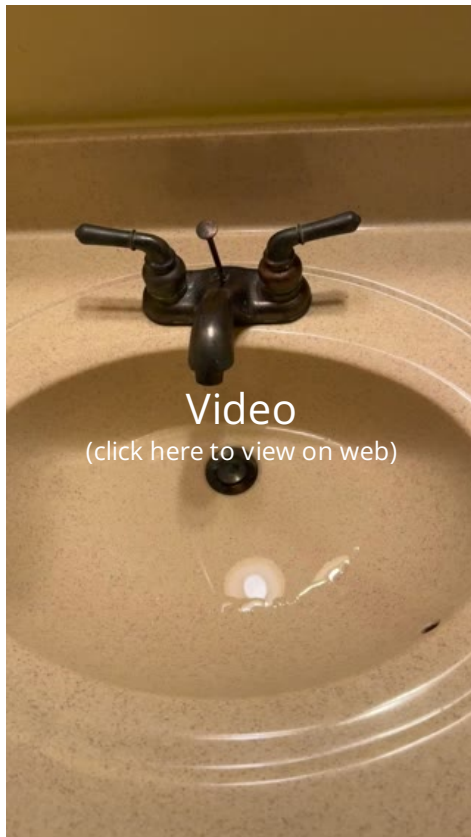
9.2.2 Sinks, Tubs & Showers  
**SINK STOPPER STUCK**

Time of inspection, sink stopper will not open, causing water to retain in sink. Recommend repair.

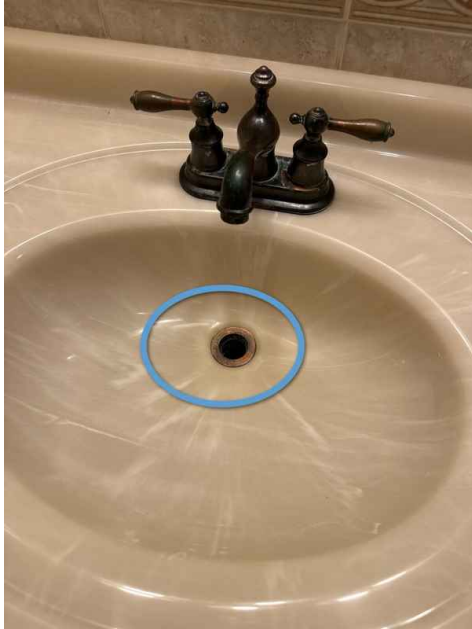
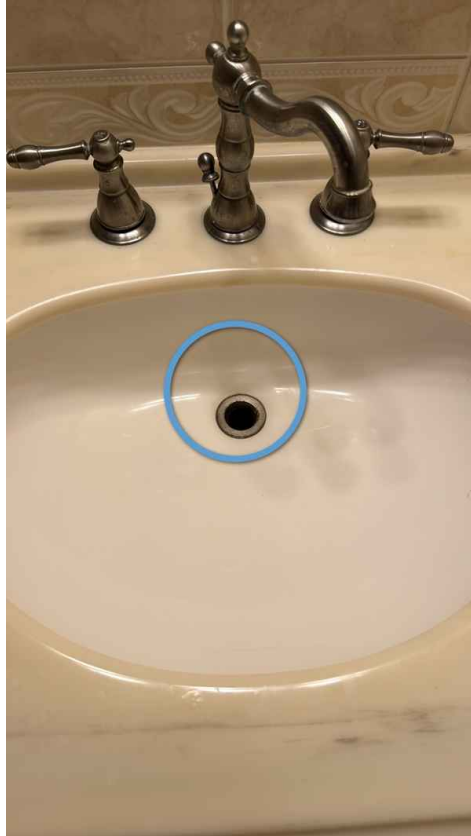
9.2.3 Sinks, Tubs & Showers

**SINK DRAIN PLUG MISSING**

At time of inspection, one or more sink drain plugs missing. Recommend repair.

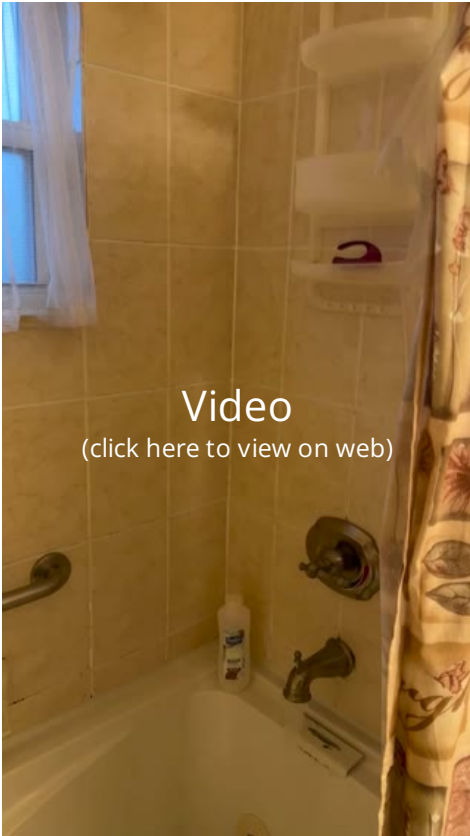
9.2.4 Sinks, Tubs & Showers

**SHOWER DIVERTER DEFECT**

What time is inspection, shower tub? Diverter appears well.  
Recommend repair by qualified plumber.

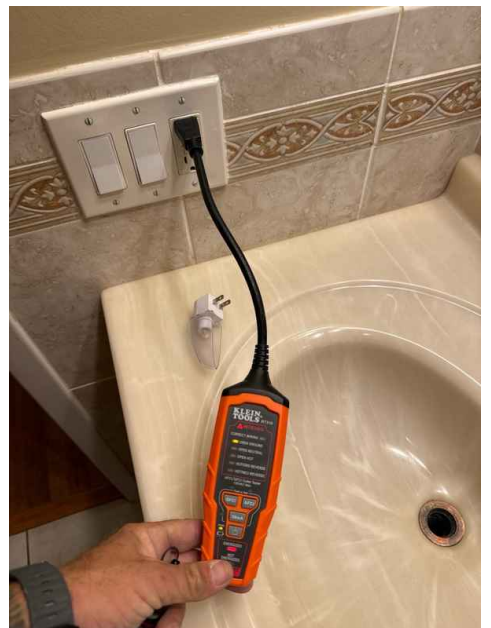
9.4.1 GFCI & Electric in Bathroom

**GFCI NOT TESTING AS FUNCTIONAL**

I observed a defect at the GFCI in the bathroom. It was not testing properly. Not functioning.

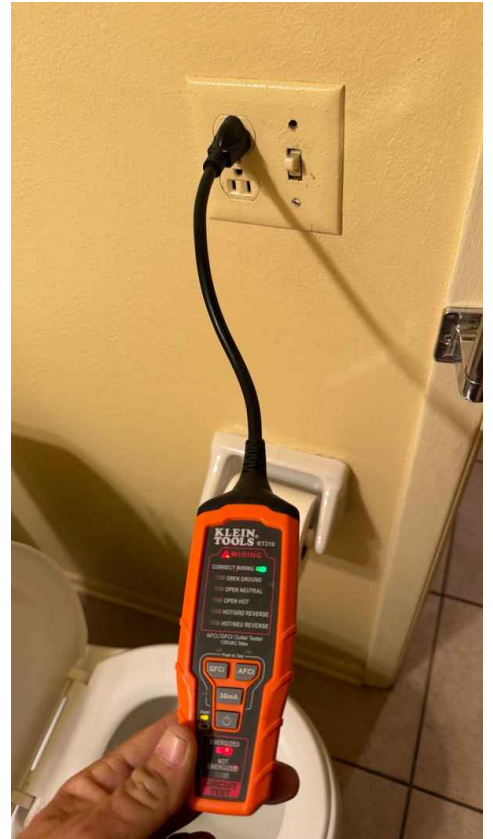
9.4.2 GFCI & Electric in Bathroom

**RECEPTACLE IS NOT GFCI PROTECTED**

I observed that the receptacle in the bathroom is not testing as being GFCI protected. This is a hazardous condition.

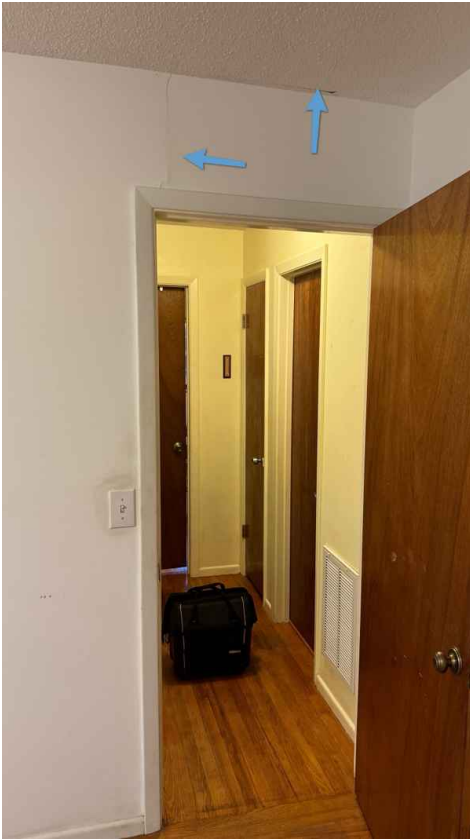
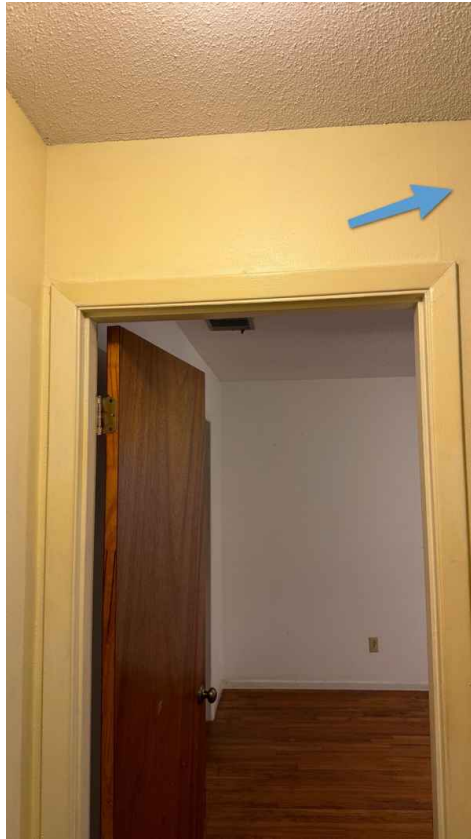
### DRYWALL CRACK

At time of inspection, drywall above door appears to be cracked on either side. This can be due to settling. I did not find any other signs of issues with foundation. Recommend patch drywall and continued watch.

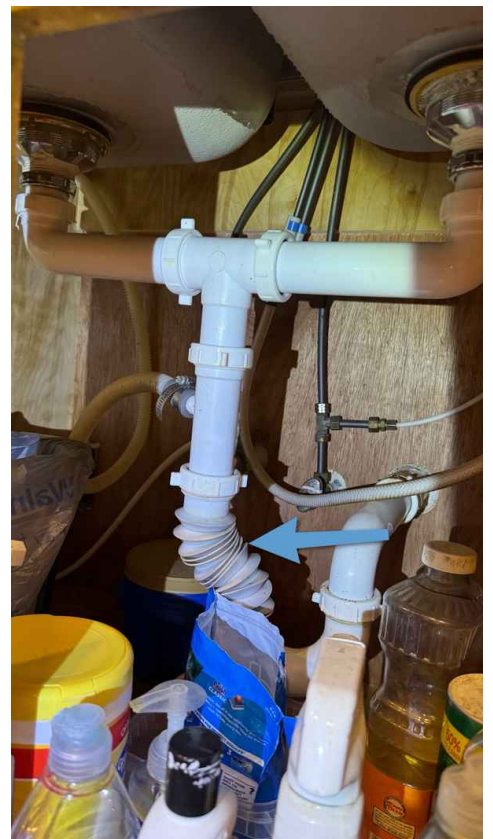
At time of inspection, flexible drain pipe found under kitchen sink. These type of pipes are prone to clog. Recommend repair.

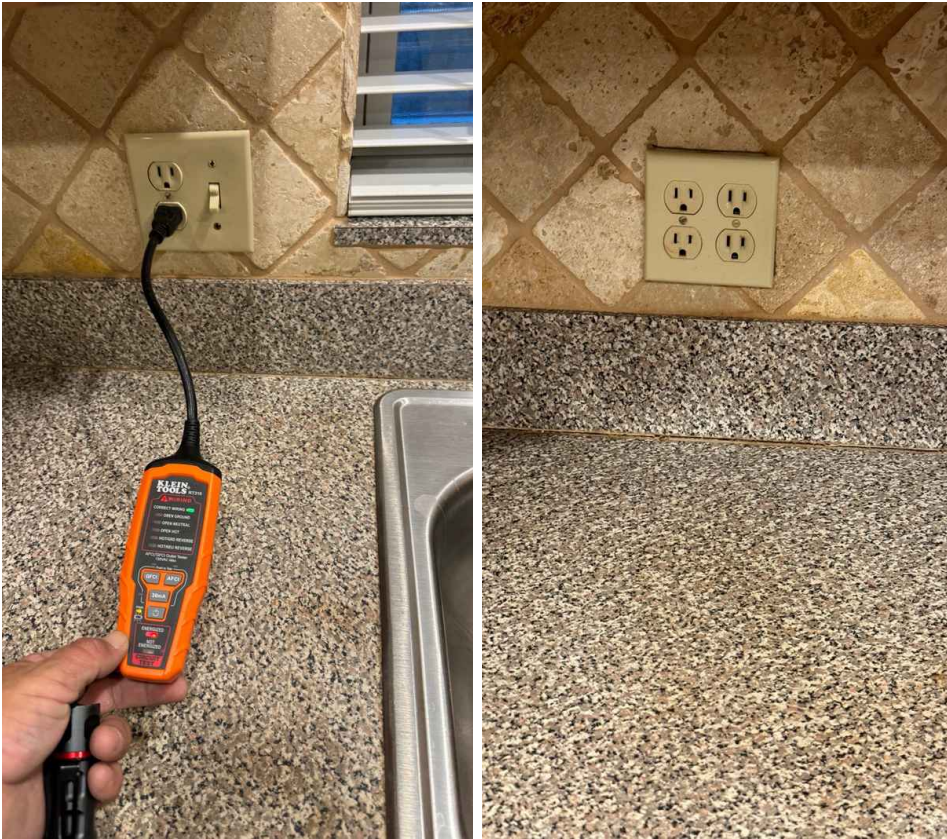
### 12.2.1 GFCI

#### **MISSING GFCI PROTECTION**

I observed indications of missing GFCI protection in the kitchen. All kitchen counter receptacles are required to be GFCI protected.
